Public Water Supply, Fair Isle (Scotland)

Client: Water Services, NI
Location: Belfast, N Ireland
Product: BoreSaver Ultra C
Project Description: The remediation of a well that had been abandoned 3 years previously due to extensive iron oxide and iron bacteria clogging
Keywords: BoreSaver Ultra C, public water supply, remediation, iron bacteria, iron oxide deposits

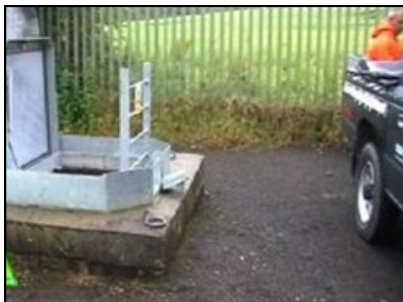
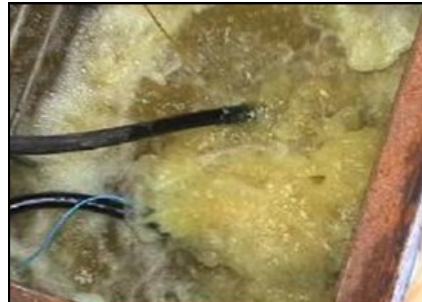
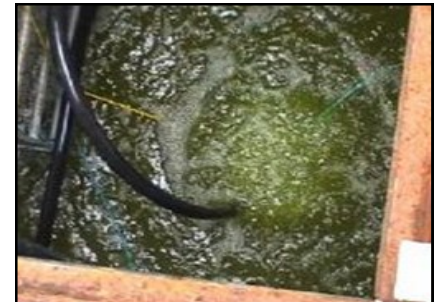
A 98m deep bore, used to supply public water for Belfast, had been abandoned three years previously due to severe iron oxide and iron bacteria contamination. A downhole video camera survey revealed that the well liners were completely clogged, with up to 5cm of film observed over a 40m length of the PVC liner. The well was unable to sustain yields of more than 0.2MI/day, despite an original yield of around 4MI/day in the early 1970's.

BoreSaver Ultra C was added to the well, resulting in removal of the iron bacteria and iron oxide deposits. The residues safely pumped away to waste. Subsequent pumping tests indicated that the original borehole yield of 4MI/day had been restored. Within one week of the remediation being completed, the borehole was brought back into public supply for the first time in 3 years.
