## Hydraulic Barrier, Falconara (Italy)

Client: Undisclosed Location: Falconara/Italy

The hydraulic barrier well for an industrial site in **Project**

**Description:** Falconara was contaminated with algae, calcium

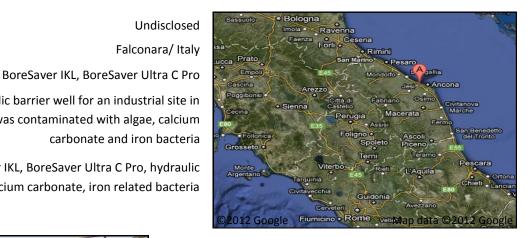
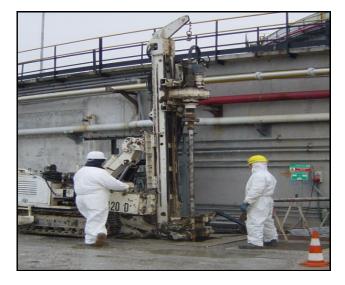
The hydraulic barrier for an industrial site in Falconara was significantly underperforming, achieving only 12m³/hr with a drawdown of 8m. A downhole video inspection revealed algae, calcium carbonate and iron bacteria contamination which had clogged up the screen slots and the pump as well as reducing the quality and output of the water. The well is 400mm in diameter and 10.5m deep.

The pump was removed from the well which was then treated with IKL Pro, Ultra C Pro and caustic soda in pearls using a piston cleaning technique. The pump was cleaned using a large barrel filled with water and Ultra C.

Following two treatments, 24 hours apart, the majority of the screen slots were completely open and the algae, calcium carbonate and iron bacteria almost completely eliminated. The submersible pump was re-installed and tested, and now achieved 28m<sup>3</sup>/hr with a drawdown of only 4.7m, an increase of 233%. As this level of pressure was not required, the flow was reduced to 21m<sup>3</sup>/hr with a drawdown of 4.40m.
